RAILWAY INVESTIGATION REPORT

R05Q0033

MAIN-TRACK DERAILMENT

MILE 21.33, VAL-D'OR SUBDIVISION

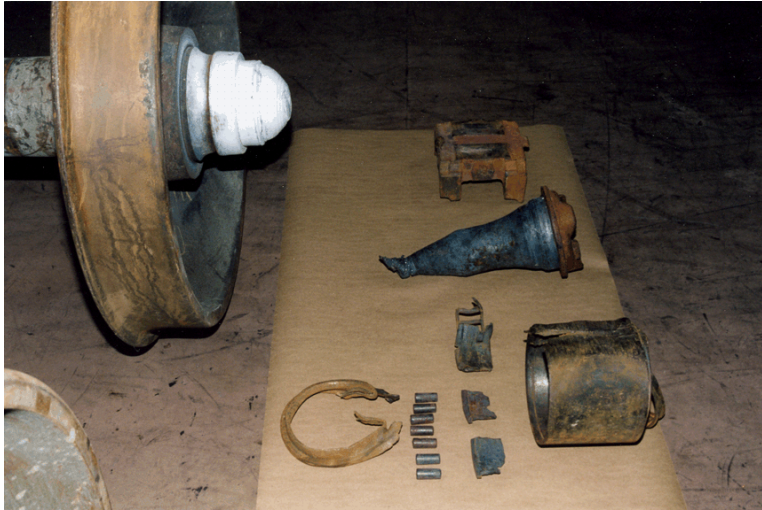
Derailed bulkhead flat car JRDX 490038,² the fifth car behind the locomotives, was missing a portion of an axle (position R-2). The axle journal along with the associated bearing was discoloured and had completely separated from the rest of its wheel set, a condition commonly described as a burnt-off journal, or BOJ. The truck side had marks indicating a recent impact on the bottom and on the trailing end of the side frame. There were no indications of impending bearing failure, such as grease spatter on the floor underframe immediately above the failed roller bearing location. The missing axle journal stub, with the bearing end cap still attached, was located on the south side of the main track at Mile 20.15.

Photo 1. Wheel and axle journal (R-2) with some of the recovered pieces

Visual examination of the bearing components of the R-2 wheel on car JRDX 490038 revealed deformation and discolouration consistent with severe overheating and bearing seizure identified in other roller bearing failures and axle burn-offs. Just before the derailment, the roller bearing overheated and seized. The axle then extruded, resulting in a reduction in cross-sectional thickness. After sufficient thinning, the overheated axle could no longer support the weight of the car, leading to a complete axle fracture.

- The bearing had been in service for 25 years and its internal parts had wear consistent with its age.
- The bearing failed as a result of overheating, most likely initiated as a result of loose components.
- Fretting wear observed on the cap screw threads and lock plate suggests that the end cap pre-load was less than required.
- Loss of bearing clamp force, due to the presence of rubber washers (seal rings) under the end cap and outboard cone growth, may have contributed to a loose bearing condition.
- Spalling of the inboard raceway of the outer race (cup), due to rolling contact fatigue, was considered indicative of overstress resulting from a loose outboard cone.

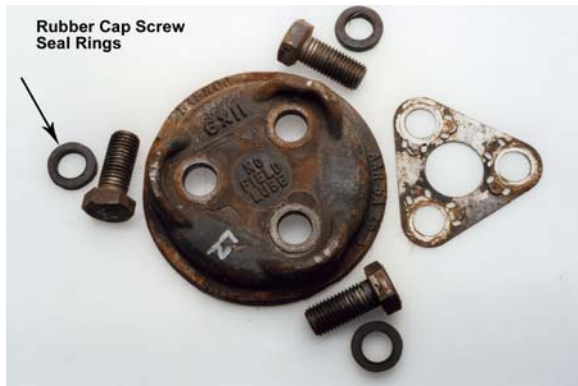
The bearings on wheel R-2 were Class E Brenco 6 X 11, AAR-5A. When they were assembled, they were equipped with rubber cap screw seal rings between the end cap and the axle. In May 1988, the AAR prohibited the further use of these cap screw seal rings as they were susceptible to reducing the clamping forces on the assembly, which can contribute to premature failure of the bearing. Examination of the end cap and related components from the R-2 position revealed only residues of these seal rings.

Photo 2. Rubber cap screw seal rings, with cap screws, end cap, and locking plate, in roller bearing at L-2 and R-2 positions

The bearing was also assembled at a time when seal rings were allowed between the end cap and the axle. These seal rings were later prohibited by the AAR due to the detrimental effect the rubber rings can have on the overall clamping force holding the many integral parts of the roller bearing assembly together. The TSB laboratory examination revealed spalled raceways due to rolling contact fatigue caused by overstress resulting from a loose outboard cone. Similarly, the fretting of the threads on the cap screws at both the L-2 and R-2 positions is another indicator of a loose bearing condition. The cumulative effect of wear and stress on each of these components must be considered. Therefore, the age of the bearing, its condition and its type of assembly are considered contributing factors to its failure.

The Association of American Railroads (AAR) issued Circular Letter c-9094, titled *Interchange Prohibition of Roller Bearing Cap Screw Seal Rings Effective January 1, 2007*. This circular letter accelerates the industry removal date, previously shown as 01 January 2014, by seven years, to a new effective date of 01 January 2007. The AAR now prohibits railways from allowing cars with bearings still equipped with cap screw seal rings, similar to the car involved in this accident, from all interchange service beyond this date. The AAR requests car owners to remove cap screw seal rings from their fleets as expeditiously as possible, and repair facilities as well as contract shops are urged to do their part to reduce the cap screw seal ring population (see Appendix B).

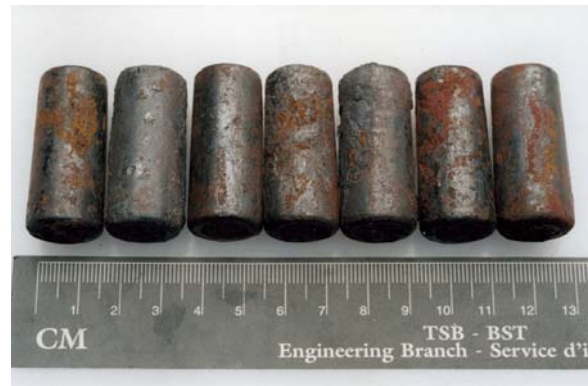
Both grease seals were recovered; the outer fused to the cup and the inner severely damaged. The roller bearings and the outer race were severely deformed and smeared, with some of the rollers fused to the inner race. Portions of the inboard inner race were recovered with rollers and cage sections fused together. Seven of the inboard tapered rollers were recovered, some showing surface spalling (see Photo 3). Closer examination of the inboard raceway of the outer race showed a significant spall on the outboard edge. Fretting wear was observed on the threads of the cap screws in the vicinity of their interaction with the end cap (see Photo 4).

Photo 3. Inner rollers from R-2 bearing

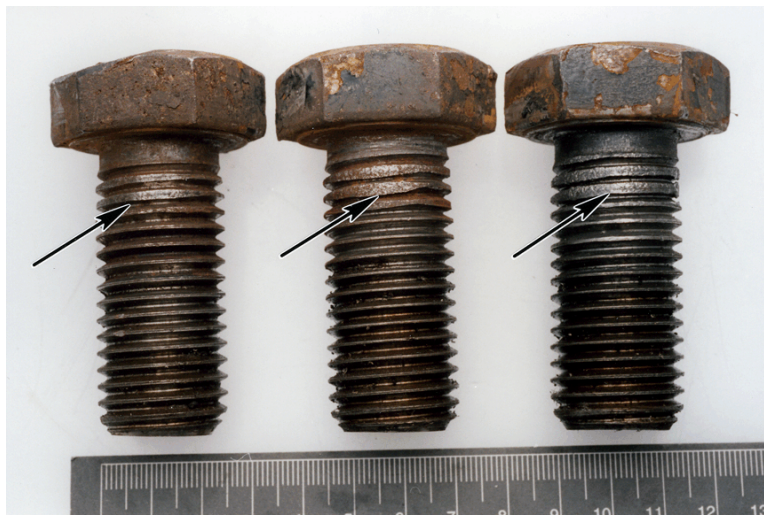
Photo 4. Fretting wear on threads of cap screws
